Maryland Historical Trust State Historic Sites Inventory Form

and/or common Gruitt Barn

7. DESCRIPTION CT-1149

#2122 - Gruitt Barn. INTENSIVE LEVEL

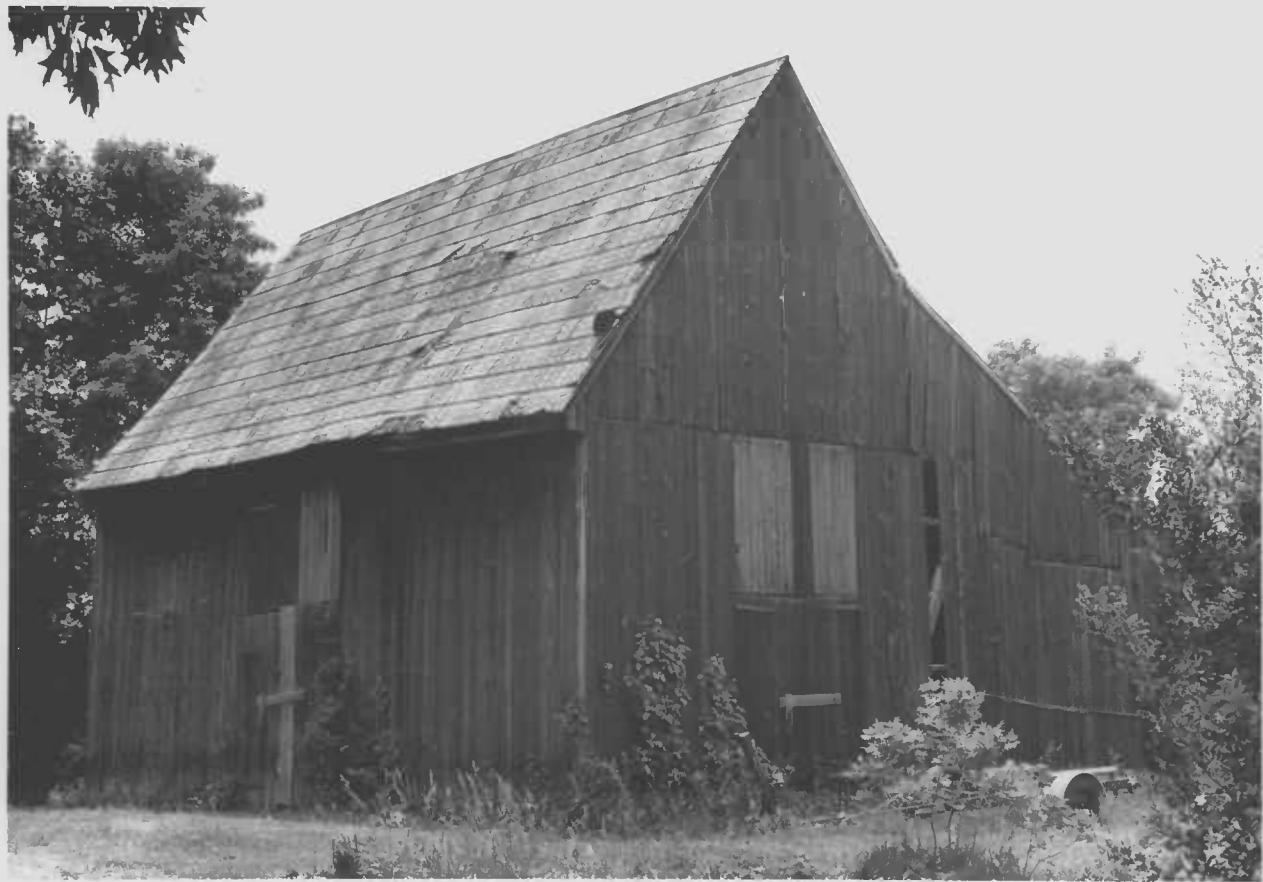
ET- 1149

NORTH WEST
